Analysis of Deterioration on Stone Surfaces: The Case of Kasimiye Madrasah

Keywords: Kasimiye Madrasah, stone deterioration, XRF chemical analysis method.

Citation: Biçen Çelik, A., Ergin, Ş., Dal, M. & Ay, İ. (2023). Analysis of Stone Deterioration on the Facades of the Kasimiye Madrasah. *Journal of Architectural Sciences and Applications*, 8 (2), 696-712.

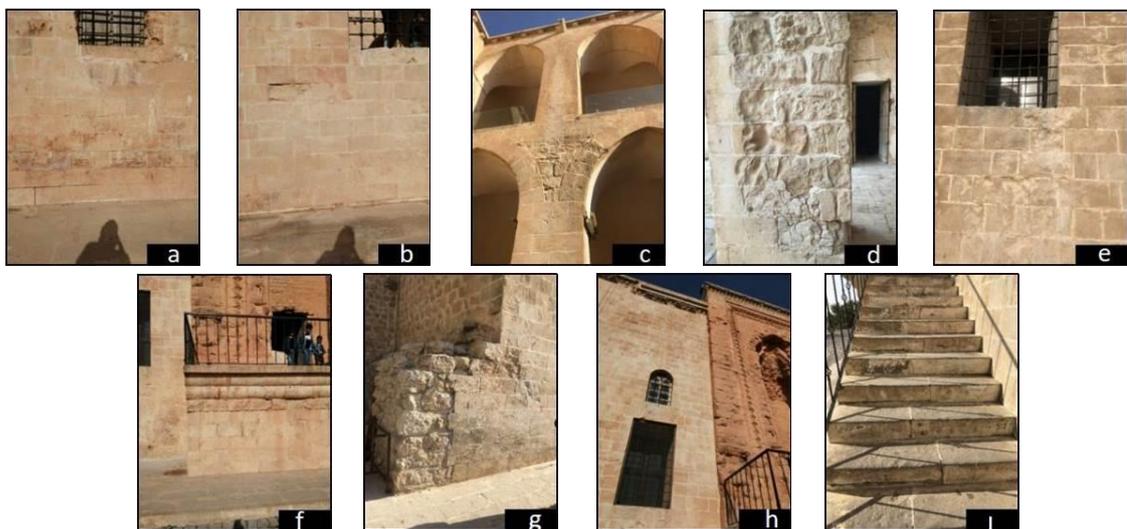
Figure 5. Physical deterioration of Kasımiye Madrasah (Biçen Çelik, 2019)

The deterioration of Kasımiye Madrasah was analysed in four groups physical, chemical, biological, and anthropogenic deterioration. The physical deterioration of Kasımiye Madrasah as a result of environmental and climatic factors is shown in Figure 5. As a result of climatic factors, capillary cracks in the walls (Figure 5a), fragment breaks in the window openings (Figure 5b), fragment breaks in the inner courtyard (Figures 5c and 5d), abrasion caused by wind-borne dust on the south façade (Figures 5e and 5f), fragment breaks, capillary cracks and joint discharges on the main portal and west façade of the building (Figures 5h and g), and abrasion on the entrance staircase due to visitor flow (Figure 5i).

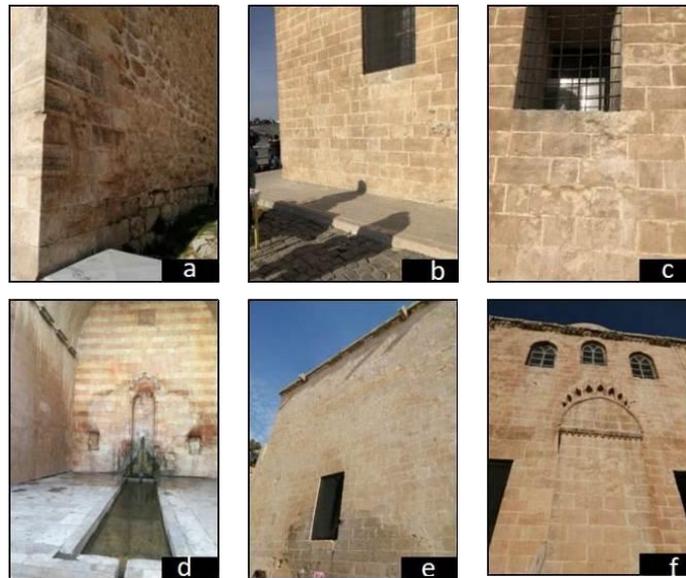
Figure 6. Chemical deterioration in Kasımiye Madrasah (Biçen Çelik, 2019)

Salination and discoloration caused by climatic factors in Kasımiye Madrasah are shown in Figure 6. Salination is caused by the dissolution and evaporation of the salts in the limestone under the influence of humidity and temperature (Figure 6a, 6b and 6c) and discoloration is caused by the interaction of the minerals in the stones (Figure 6d, 6e and 6f) were observed.

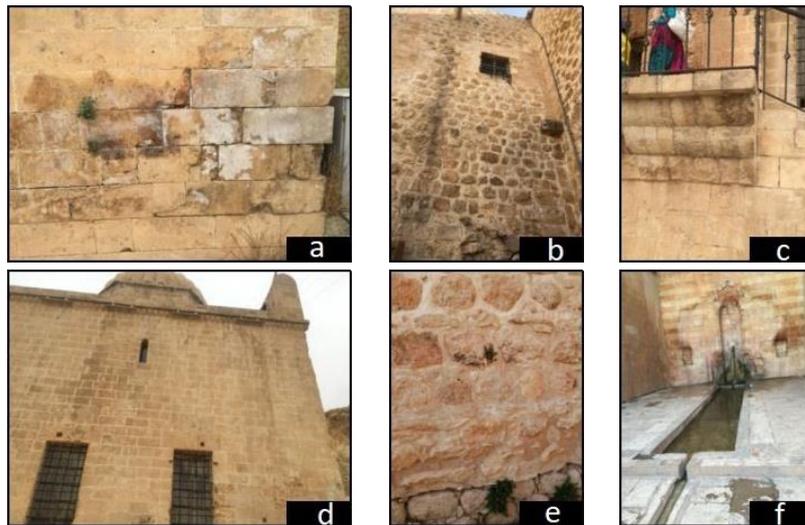
Figure 7. Biological deterioration in Kasımiye Madrasah (Biçen Çelik, 2019)

Biological deterioration occurring in Kasımiye Madrasah is shown in Figure 7. Plant formations are observed as a result of the interaction of the seeds that settle inside the capillary cracks with water (Dal & Yardımlı, 2019). Plant formations were observed on the south façade (Figure 7a) and east façade (Figure 7e) of the building, biochemical deterioration caused by bacteria settled on the stone surfaces (Figures 7b and 7c), deterioration caused by bird droppings (Figure 7d) and moss formations in the selsebilli iwan (Figure 7e).

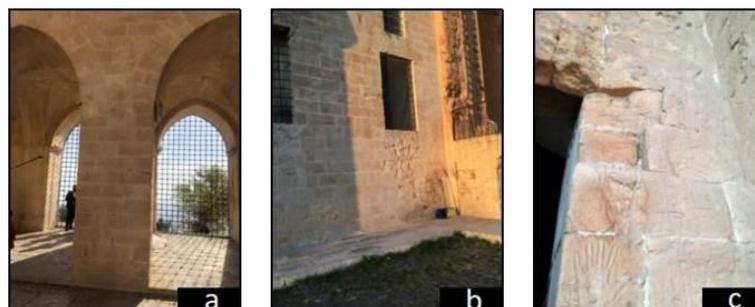
Figure 8. Anthropogenic deterioration of the Kasımiye Madrasah (Biçen Çelik, 2019)

The deterioration of Kasımiye Madrasah as a result of anthropogenic impacts is shown in Figure 8. As a result of the damage caused to the building by unconscious users with sharp tools, deterioration was observed on different facades (Figure 8a, 8b and 8c).
