Analysis of Deterioration on Stone Surfaces: The Case of Kasimiye Madrasah

Keywords: Kasimiye Madrasah, stone deterioration, XRF chemical analysis method.

Citation: Biçen Çelik, A., Ergin, Ş., Dal, M. & Ay, İ. (2023). Analysis of Stone Deterioration on the Facades of the Kasimiye Madrasah. *Journal of Architectural Sciences and Applications*, 8 (2), 696-712.

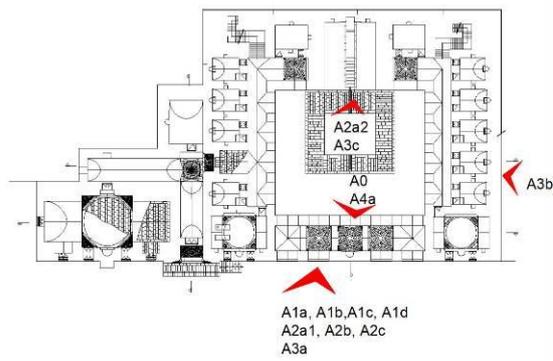
Figure 9. The plan representation of the stones selected for the use of XRF chemical method for the deterioration of the Kasimiye Madrasah

All types of deterioration occurring in the Kasımiye Madrasah were analysed with the codes determined by X-Ray Fluorescence Spectroscopy (XRF chemical analysis method). The codes determined (Table 6), the representations of the selected stones on the plan (Figure 9) and on the facade (Figure 10) are given below. The main purpose of analysing the materials of historical buildings is to obtain information about the production technology as well as the physical and chemical composition of the materials (Karataş, Alptekin & Yakar, 2022).

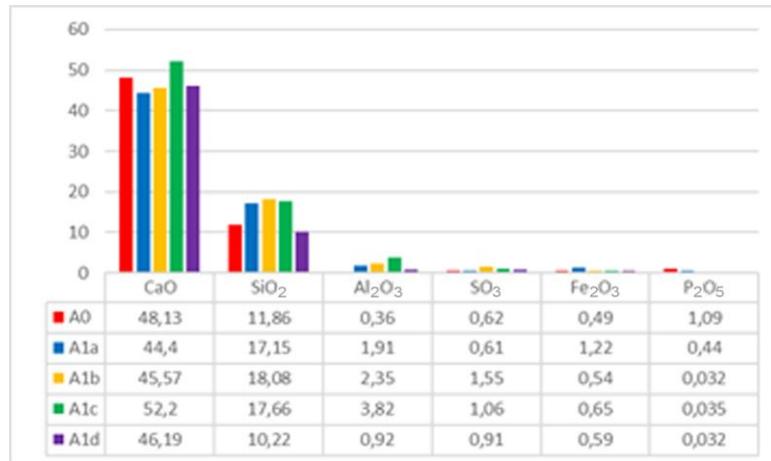
Table 7. XRF chemical analysis results of physical deterioration observed on the facades of Kasimiye Madrasah

The results of the analysis of the physical deterioration in Kasimiye Madrasah according to XRF analysis method are given in Table 7. According to the analysis results, changes in SO_3 , SiO_2 and CaO ratios are remarkable. An increase in SO_3 occurred in A1b stone. The increase in SO_3 ratio is due to the air pollution of the stone. It can be said that the strength of the stone increases with the increase in SiO_2 ratio. While the SiO_2 ratio was 11.86% in A0 stone, this ratio was 18.08% in A1b stone. The clays decomposed on the stone surface cause the SiO_2 ratio to increase. Changes are observed in the stones due to daily and annual temperature differences and different minerals in the stones. Physical deterioration such as capillary cracks, surface abrasions and fragment fractures were observed in Kasimiye Madrasah (Karataş, Alptekin & Yakar, 2023).

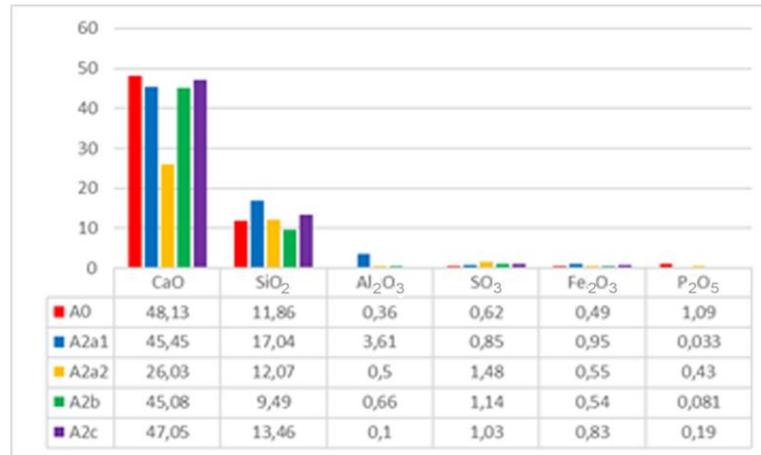
Table 8. XRF chemical analysis results of chemical deterioration observed on the facades of Kasimiye Madrasah

The results of XRF chemical analyses of the chemical deterioration in Kasimiye Madrasah are shown in Table 8. According to the results obtained, it is seen that the CaO ratio decreased in stone A0 compared to other stones. Since the SO_3 ratios in A2a2 and A2b stones are high, it can be said that they are affected by air pollution. While the SiO_2 ratio was 11.86% in A0 stone, this ratio increased to 17.04% in A2a1 stone. This increase is due to the carbonated silica and marl (clayey limestone) content in the structure of the stone. When other compounds are examined, it is seen that there are no serious changes (Table 8).

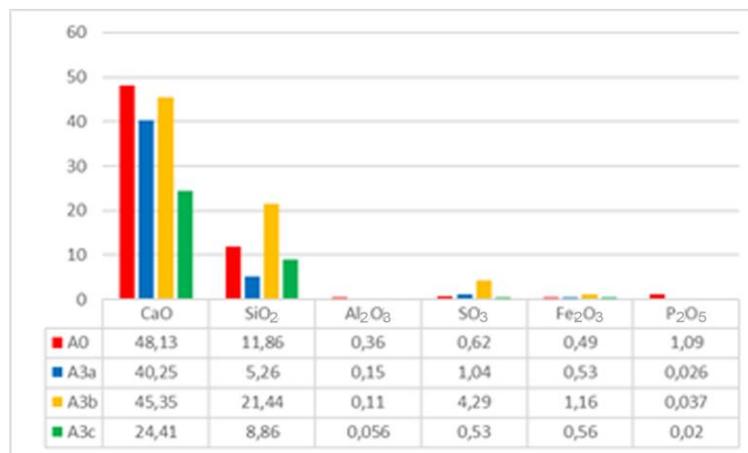
Table 9. XRF chemical analysis results of biological deterioration observed on the facades of Kasimiye Madrasah

The results of the analysis of biodeterioration in Kasimiye Madrasah are given in Table 9. According to the analysis results, a decrease in CaO ratio was observed. It can be said that the reason for the decrease in CaO ratio in stone A3c is the interaction of acids secreted by bacteria. The change in the SiO_2 ratio in stone A3b draws attention. While this ratio was 11.86% in stone A0, it was measured as 21.44% in stone A3b. No significant changes were observed in other compounds (Table 9).

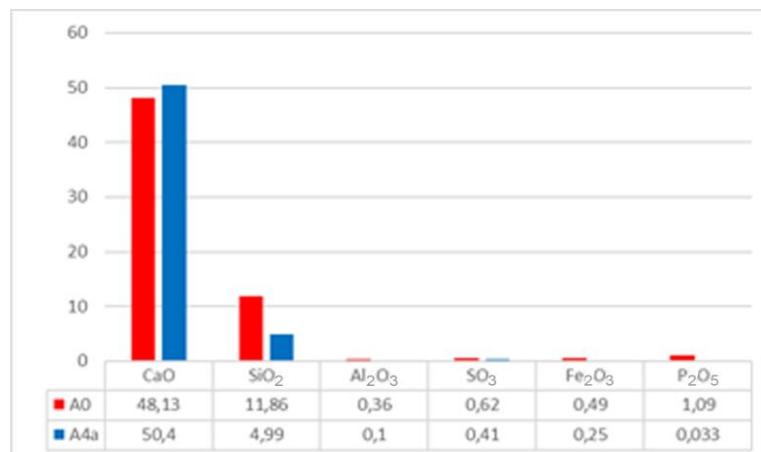
Table 10. XRF chemical analysis results of anthropogenic deterioration observed on the facades of Kasimiye Madrasah

When the anthropogenic deterioration in Kasimiye Madrasah was analysed by XRF chemical analysis method, an increase in CaO ratio and a decrease in SiO₂ ratio were observed. While the SiO₂ ratio was 11.86% in stone A0, this ratio decreased to 4.99% in stone A4a. Clay deposits were observed from the degraded stone surfaces (Table 10).
