Water Quality Properties of Acı Lake and Meke Lake (Konya, Turkey)

RESEARCH ARTICLE

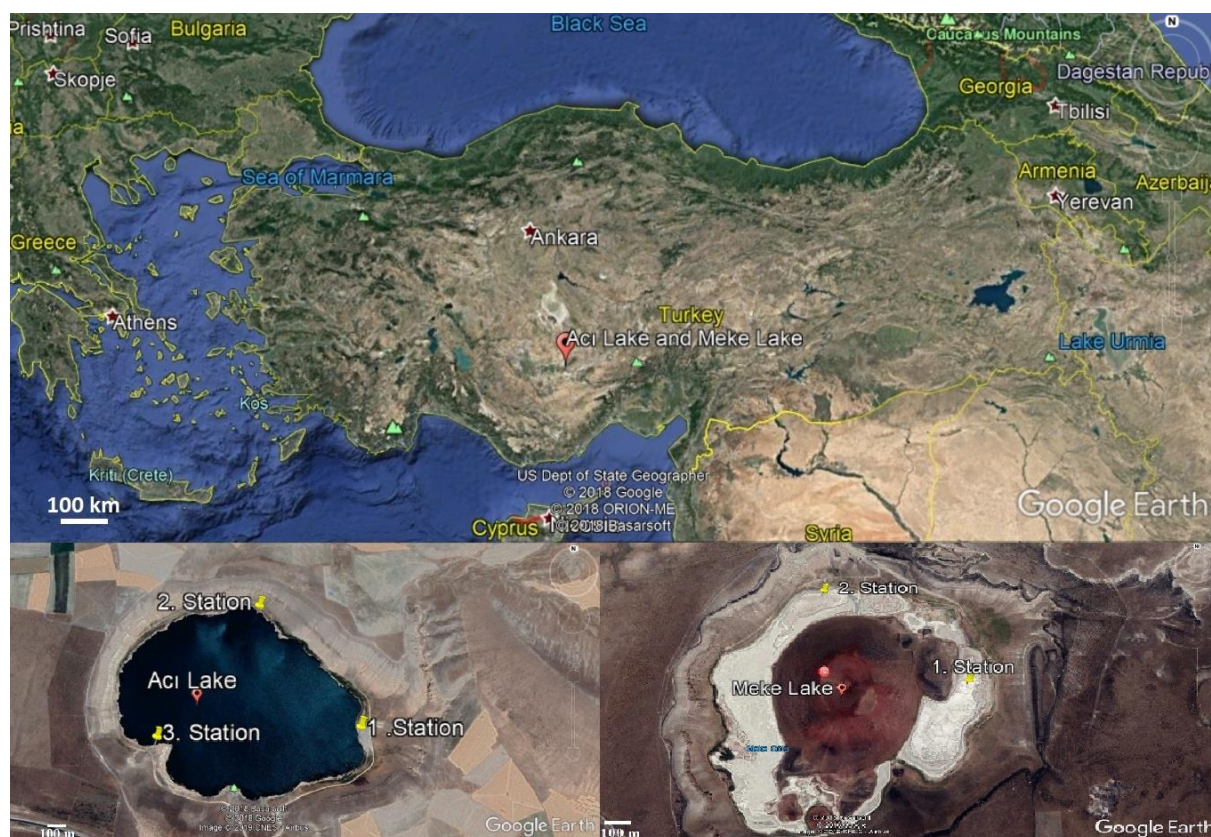
Figure 1. Satellite images of Acı Lake and Meke Lake sampling stations (Google 2018)

Study materials were taken from stations capable of characterizing lakes for analysis. Satellite images of Acı Lake and Meke Lake sampling stations are given in Figure 1.

Station 1: The station is located to the east of the lake. Its ground is covered with mud. Station coordinates; 37°42'42" N, 33°40'23" E.

Station 2: The station is located to the north of the lake. Its ground is covered with mud. Station coordinates; 37°43'05" N, 33°40'01" E.

Station 3: The station is located to the south west of the lake. Its ground is covered with small stones. Station coordinates; 37°42'40" N, 33°39'38" E.

Station 1: The station is located to the north of the lake. Its ground is covered with salt layer. Station coordinates; 37°41'08" N, 33°38'44" E.

Station 2: The station is located east of the lake. Its ground is covered with salt layer. Station coordinates; 37°41'24" N, 33°38'18" E.
